INDOOR AIR QUALITY ASSESSMENT

**Veterans Memorial School
10 Webster Street
Gloucester, MA 01930**

Prepared by:
Massachusetts Department of Public Health
Bureau for Environmental Health
Emergency Response/Indoor Air Quality Program
June 2007

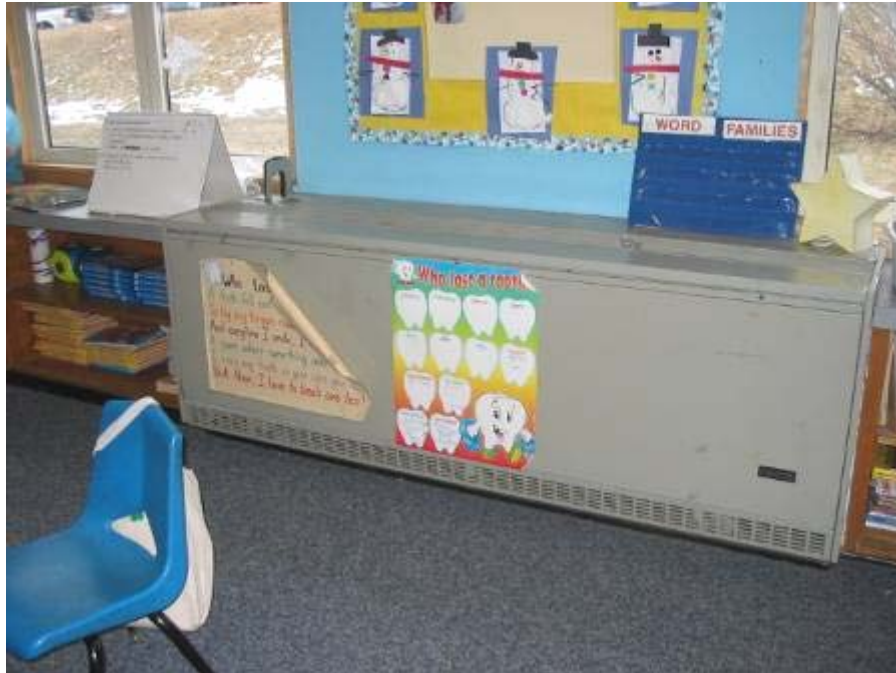
Picture 1

Fresh air in classrooms is supplied by unit ventilator (univent) systems (Picture 1). A univent is designed to draw air from outdoors through a fresh air intake located on the exterior wall of the building (Picture 2) and return air through an air intake located at the base of the unit ([Figure 1](#)). Fresh and return air are mixed, filtered, heated and provided to classrooms through an air diffuser located in the top of the unit. Many univents were operating weakly or found to be off at the time of assessment. Obstructions to airflow, such as papers and books stored on univents and bookcases and carts and desks located in front of univent returns, were seen in a few classrooms. In some cases, univents were used to dry art projects (Pictures 3 and 4, Table 1). In order for univents to provide fresh air as designed, units must be allowed to operate and remain free of obstructions.

Classroom univent

2. Examine each univent for function. Survey classrooms for univent function to ascertain if an adequate air supply exists for each room. Operate univents while classrooms are occupied. Check fresh air intakes for repair and increase the percentage of fresh air intake if necessary.

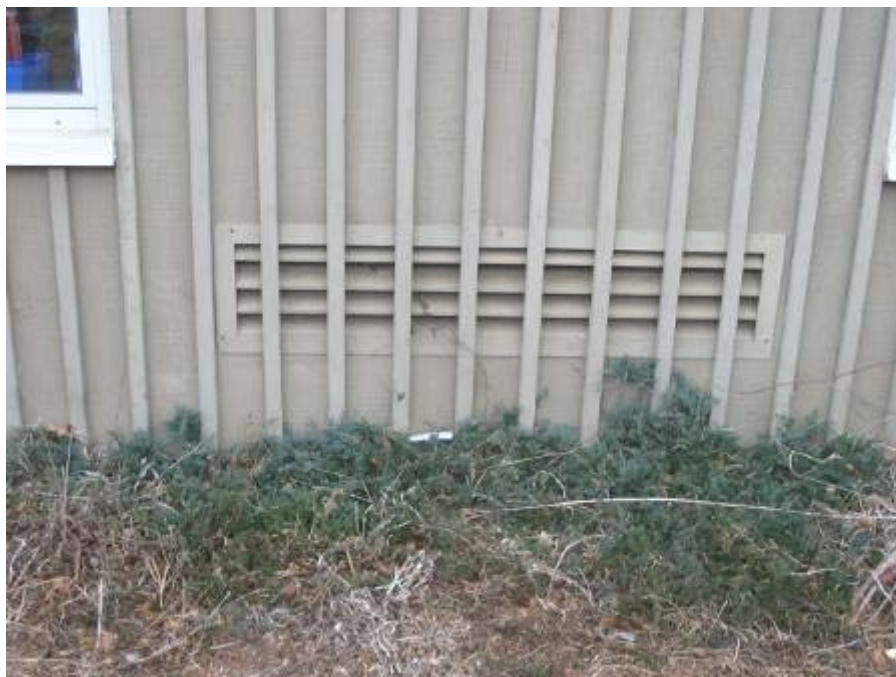
Picture 2

Univent fresh air intake

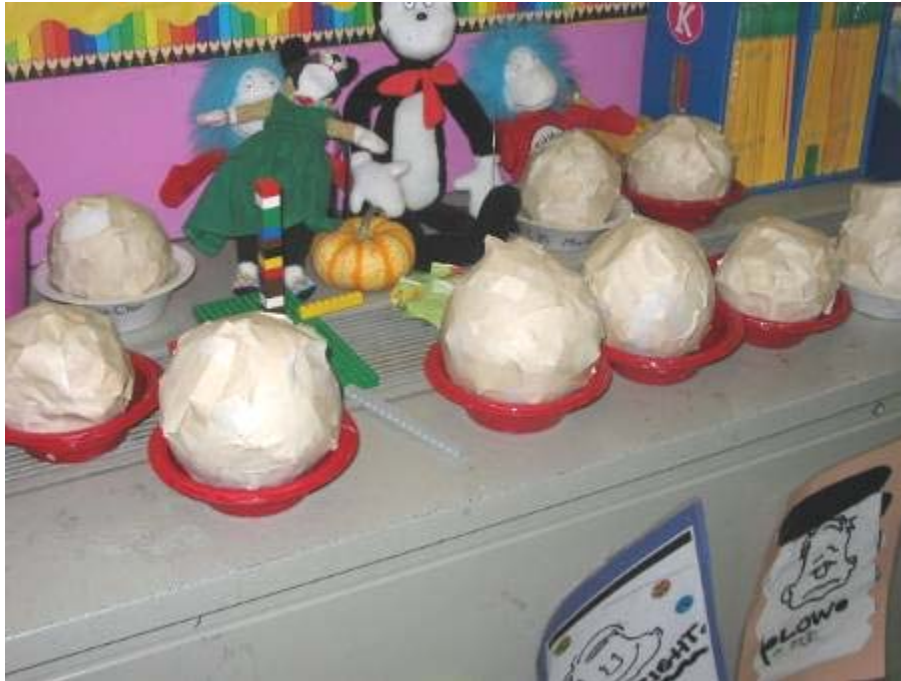
Picture 3

Paper project drying on univent

3. Remove all blockages from univents and exhaust vents to ensure adequate airflow. Clean univent and exhaust vents periodically to prevent excessive dust build-up.

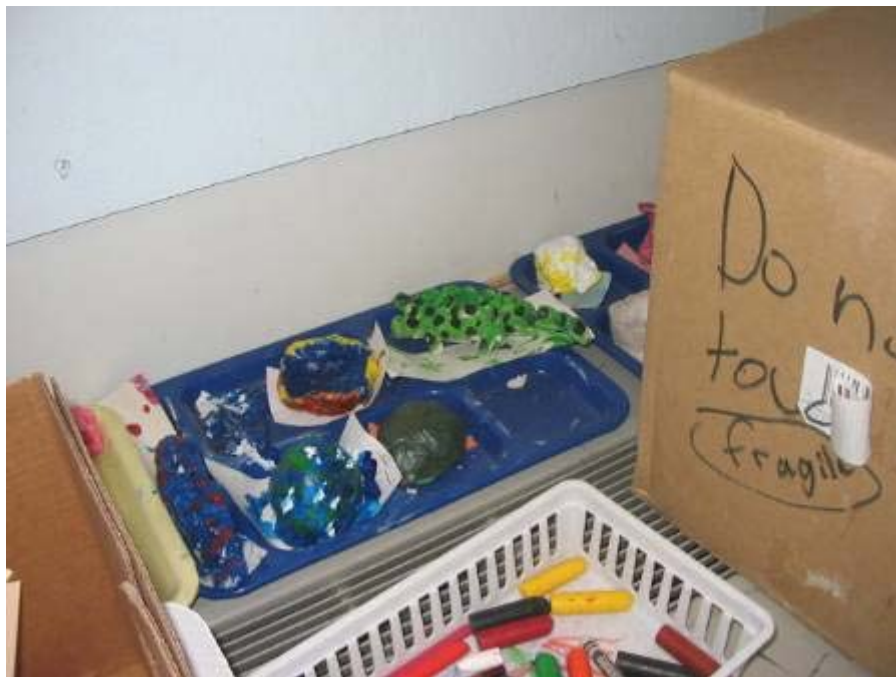
Picture 4

Items blocking univent diffuser

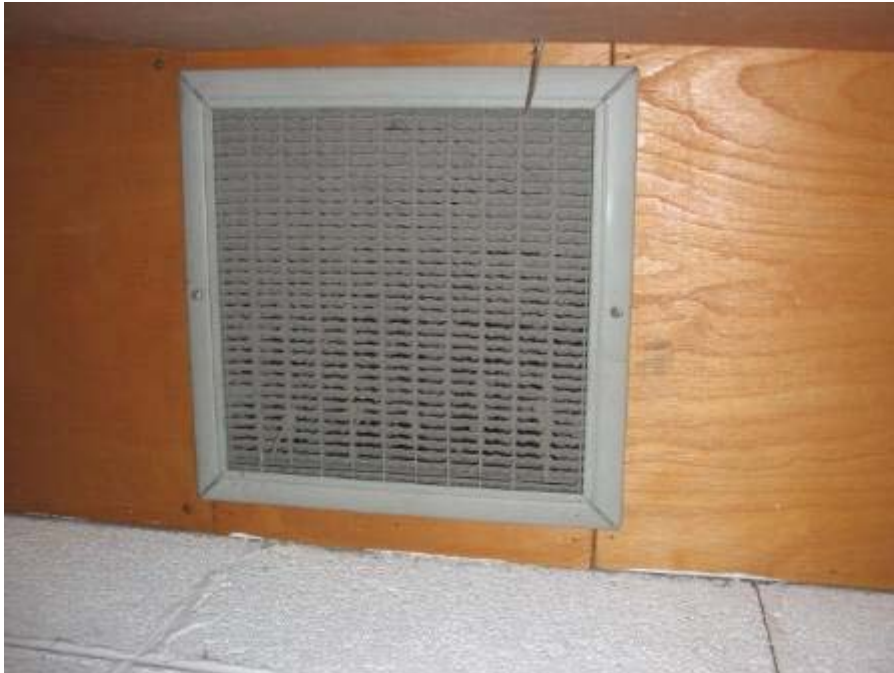
Picture 5

Exhaust ventilation in classrooms is provided by ducted and grated closet, wall or ceiling vents (Pictures 5 and 6) powered by rooftop motors. Classroom exhaust was operating at the time of assessment. A number of wall exhaust vents were also obstructed by desks, bookcases and other items (Picture 7). As with the univents, in order to function properly, exhaust vents must be activated and remain free of obstructions. Some areas did not have mechanical supply and/or exhaust. Without mechanical ventilation, normally occurring pollutants can accumulate.

A number of exhaust/return vents, univent supply vents and personal fans were observed to have accumulated dust (Pictures 5 and 8). If exhaust vents are not functioning, backdrafting can occur, which can re-aerosolize accumulated dust particles. Re-activated univents and fans can also aerosolize dust accumulated on vents/fan blades. As discussed, dust is a respiratory irritant.

Exhaust vent in closet ceiling

20. Clean accumulated dust from exhaust vents and blades of personal fans.
21. Store cleaning products properly and out of reach of students.
22. Replace latex-based tennis balls with latex-free tennis balls or rubber booties.

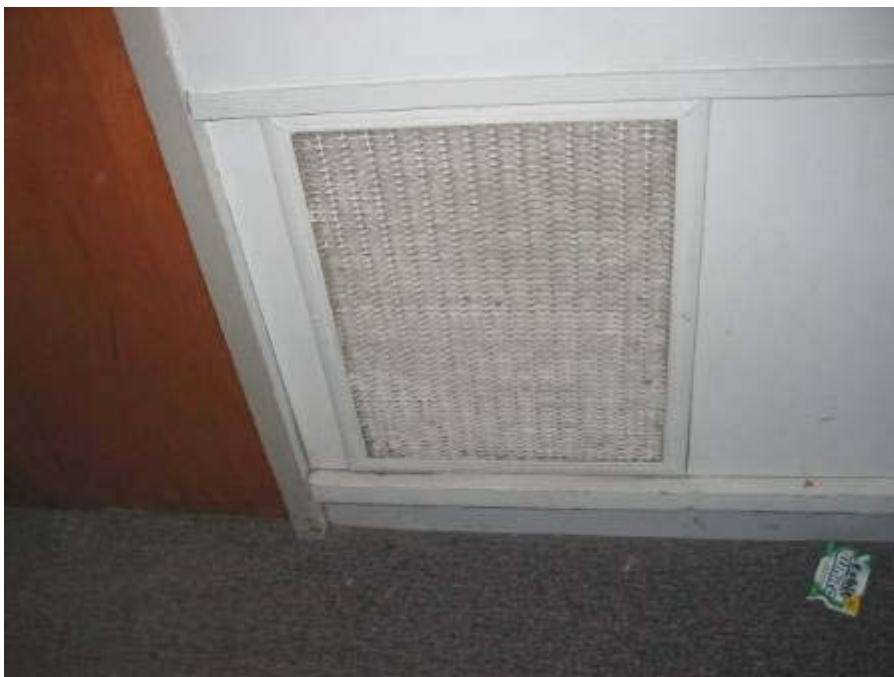
Picture 6

Wall-mounted exhaust vent

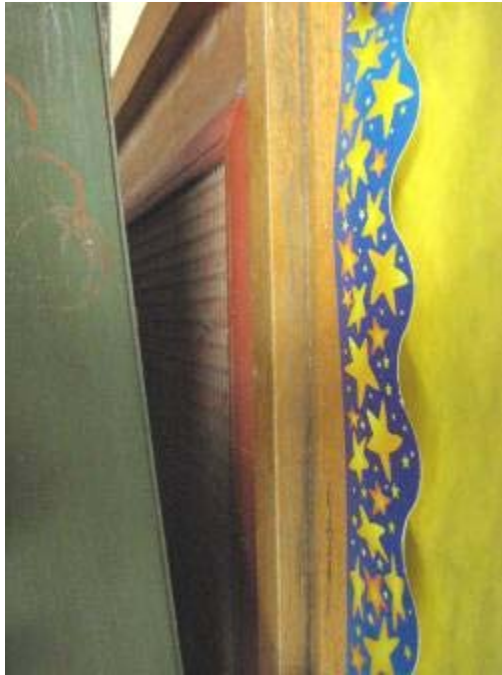
Picture 7

Wall-mounted exhaust vent blocked by bookcase

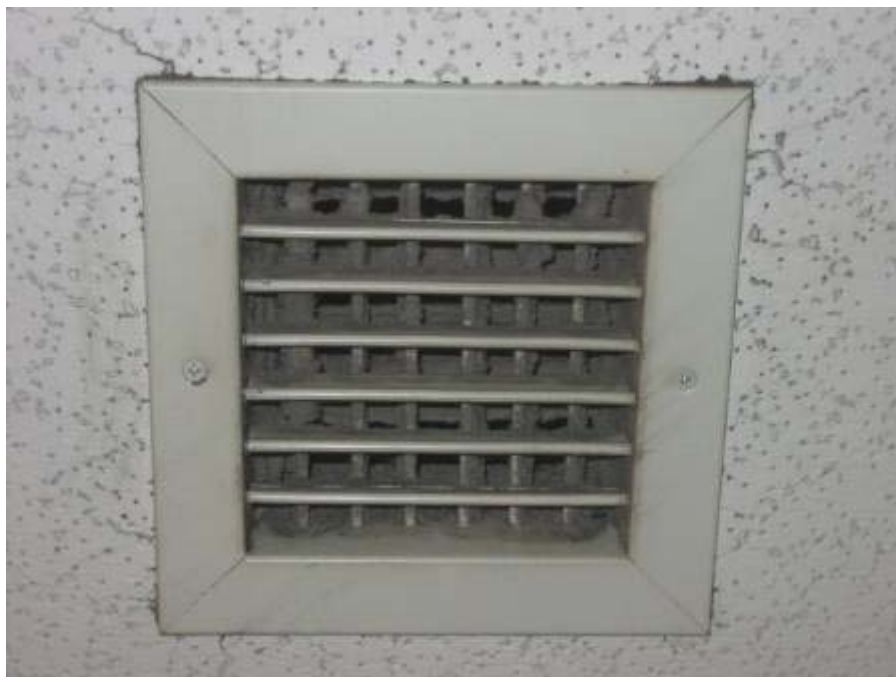
Picture 8

Mechanical ventilation to common areas and offices is provided by rooftop air handling units (AHUs). Fresh air is distributed via ductwork connected to ceiling-mounted air diffusers. Air is returned to the AHUs through ceiling-mounted return vents (Picture 8).

Ceiling-mounted exhaust vent

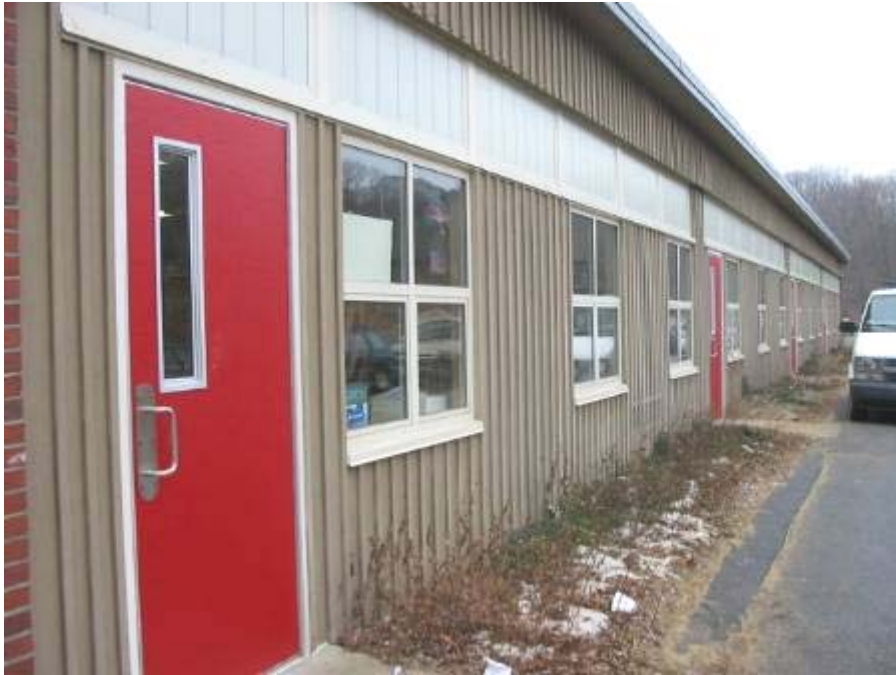
Picture 9

In addition, plants were observed to be growing against the foundation walls (Picture 9). The growth of roots against exterior walls can bring moisture in contact with the foundation. Plant roots can eventually penetrate, leading to cracks and/or fissures in the sublevel foundation. Over time, this process can undermine the integrity of the building envelope, providing a means of water entry into the building via capillary action through foundation concrete and masonry (Lstiburek & Brennan, 2001).

Exterior of 1993 building

11. Remove plants from the wall/tarmac junction around the perimeter of the building. Seal the wall/tarmac junction with an appropriate sealer.
12. Unclog weep holes to allow for proper drainage of water from the 1956 building.

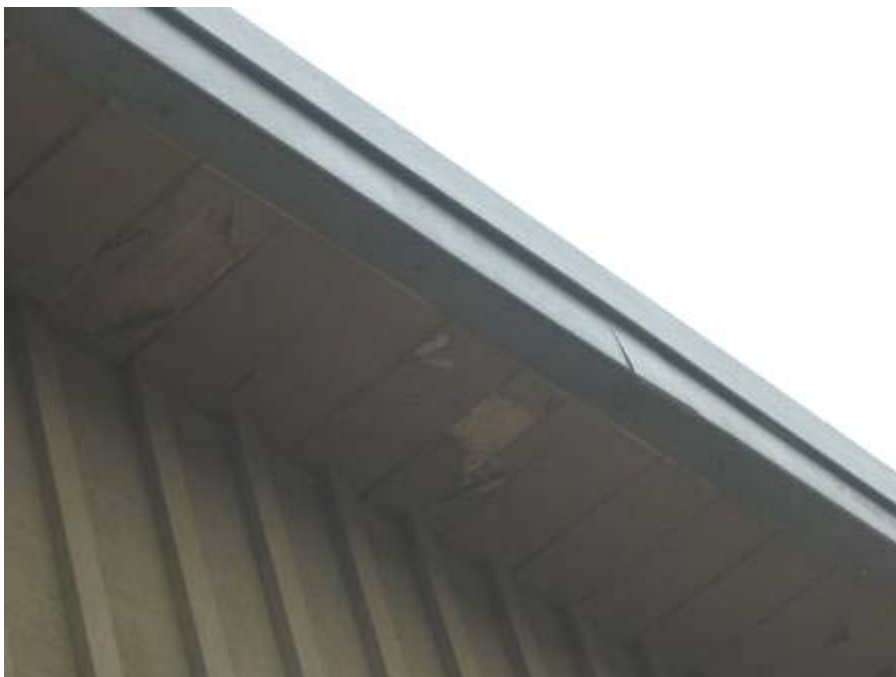
Picture 10

While the source of the odors could not be determined, one potential source for moisture penetration in the 1993 portion of the building is the building's exterior. It appears that the building's exterior consists of engineered (i.e., strand board) wood (Picture 9), similar to that used for modular buildings. In some areas of the building, the exterior appears to show damage (Picture 10). Of note is the penetration of water into the building through the univent fresh air intake casing (Picture 2). As previously discussed, each univent has a fresh air intake located on the exterior of the building. Each fresh air intake is mounted directly onto the building exterior with screws. These screws appear to show signs of weathering (Picture 12). The top portion of the fresh air intake cases as well as each louver of the intake show staining. Since these cases are not flush/within the wall and do not have flashing installed over the top of the univent grates, the staining is an indication that water is being retained on the lip of the case/against the exterior wall.

Damaged exterior on 1993 building

9. Repair damage to exterior walls to 1993 building, and re-point the exterior brick wall of 1956 building to prevent water penetration to the building.

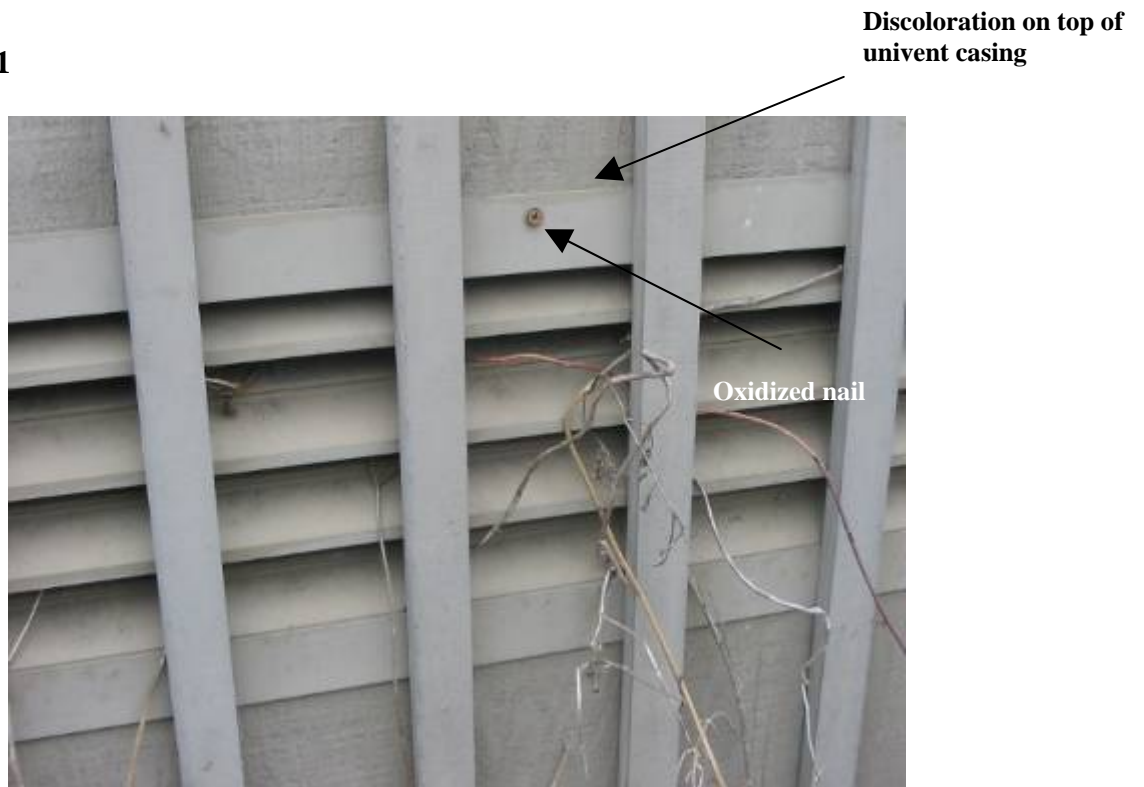
Picture 11

It does not appear that a seal exists between the case and the wall. Without any sealant, water can penetrate through the breach and moisten insulation between the exterior and interior walls. Insulation can act as a wick, drawing moisture towards the interior of the building, potentially moistening the interior wall.

Since moisture may be penetrating through the breach between the fresh air univent intake case and the exterior wall, the exterior wallboard directly behind the intake case may also be water damaged. As with insulation, these materials may be prone to mold growth if not allowed to dry sufficiently. Due to proximity, odors produced by the moistened insulation and damaged exterior wall can be drawn into the fresh air intake, become entrained in the univent and be distributed throughout the classroom.

Univent casing

10. Seal spaces between univent casing and exterior wall of 1993 building to prevent water penetration and subsequent damage to insulation and building. This may be accomplished by installing flashing in the seams.

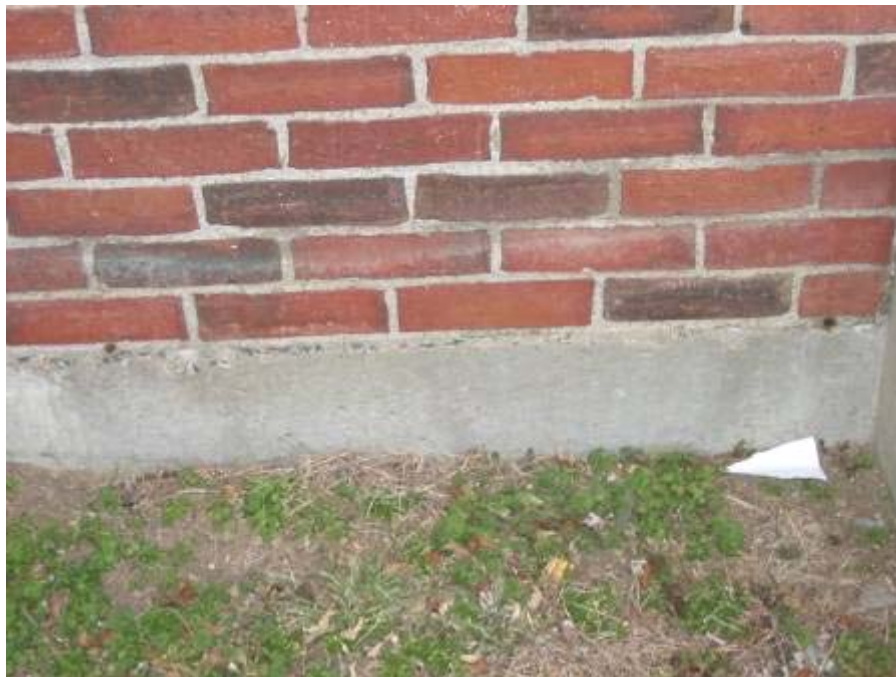
Picture 12

BEH staff examined the exterior wall and could not locate weep holes in one wall section. It also appears that weep holes were sealed/clogged in another wall section (Picture 12). Weep holes are designed to provide for water drainage. Exterior wall systems *should* be designed to prevent moisture penetration into the building interior. An exterior wall system should consist of an exterior curtain wall ([Figure 2](#)). Behind the curtain wall is an air space that allows for water to drain downward and for the exterior cladding system to dry. Opposite the exterior wall and across the air space is a continuous, water-resistant material adhered to the back up wall that forms the drainage plane.

Clogged weep holes

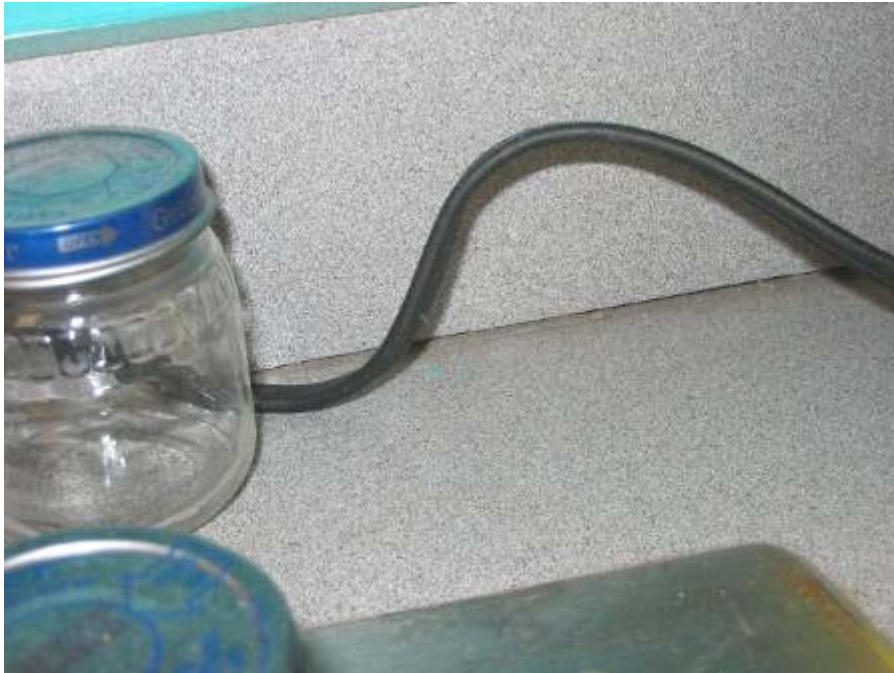
Picture 13

Open seams between sink countertops and walls were observed in several rooms (Picture 13). If not watertight, water can penetrate through the seam, causing water damage. Improper drainage or sink overflow can lead to water penetration into the countertop, cabinet interior and areas behind cabinets. Water penetration and chronic exposure of porous and wood-based

Breach between sink backsplash and counter top

13. Seal breaches between the sink backsplash and counter top to prevent damage.
14. Maintain plants to prevent growth and odors.
15. Clean and maintain aquariums and terrariums to prevent mold growth and associated odors.

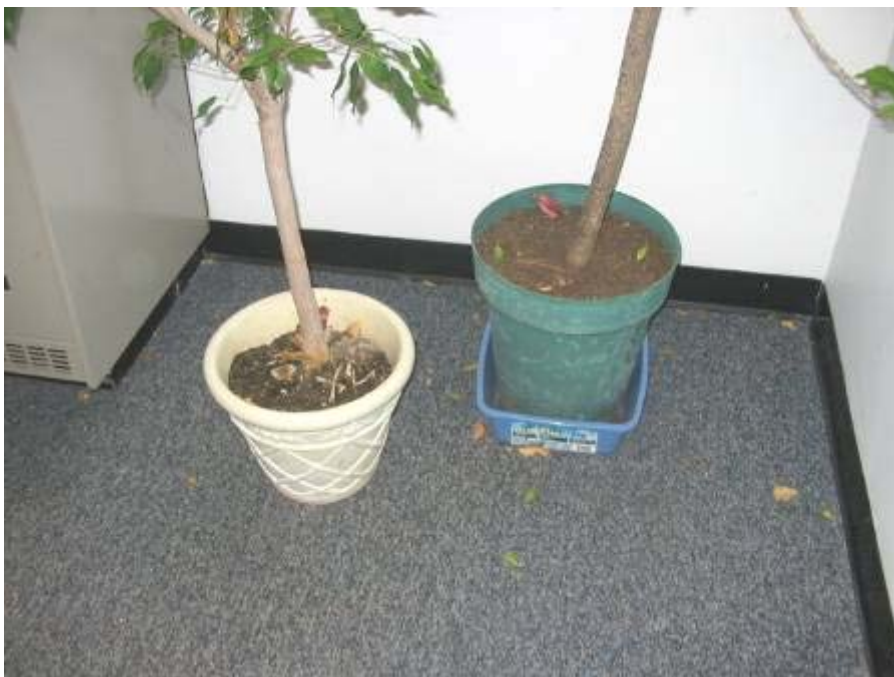
Picture 14

Plants were also observed in several classrooms. Some plants were observed on carpets (Picture 14). Plants, soil and drip pans can serve as sources of mold growth, thus should be properly maintained. Over-watering of plants should be avoided and drip pans should be inspected periodically for mold growth. Plants and related materials should also be located away from ventilation sources to prevent aerosolization of dirt, pollen, odors or mold.

Plants on carpeting

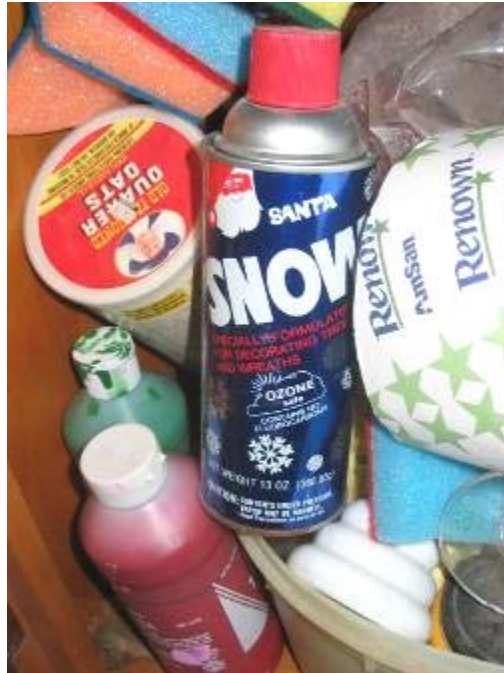
Picture 15

One classroom contained a product known as “Artificial Snow” (Picture 15), which simulates frost on windows. This spray product contains the flammable materials heptane and xylene (CPC, 1998). Heptane and xylene are volatile organic compounds (VOCs) that are associated with irritation to the eyes, nose and throat.

Artificial snow

16. Remove artificial snow canister and similar materials to prevent irritant symptoms.
17. Seal utility holes and breaches to prevent movement of odors and materials to occupied areas.

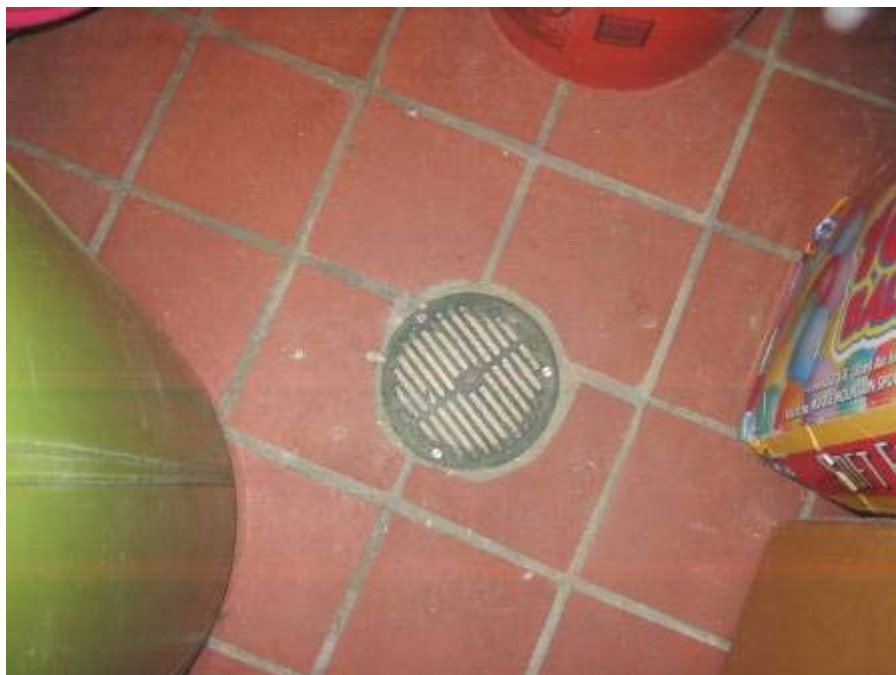
Picture 16

Dry drain odors stemming from old drains in the gym office were voiced as a concern. At the time of assessment, all drains appeared to have been filled with cement (Picture 16). According to VMS staff, these drains were sealed in October 2006. No odors have been detected since this remediation. The potential for other odors to persist in this office exists. New athletic equipment is stored in the gym office. As previously mentioned, the gym office lacks

Cement filled drain

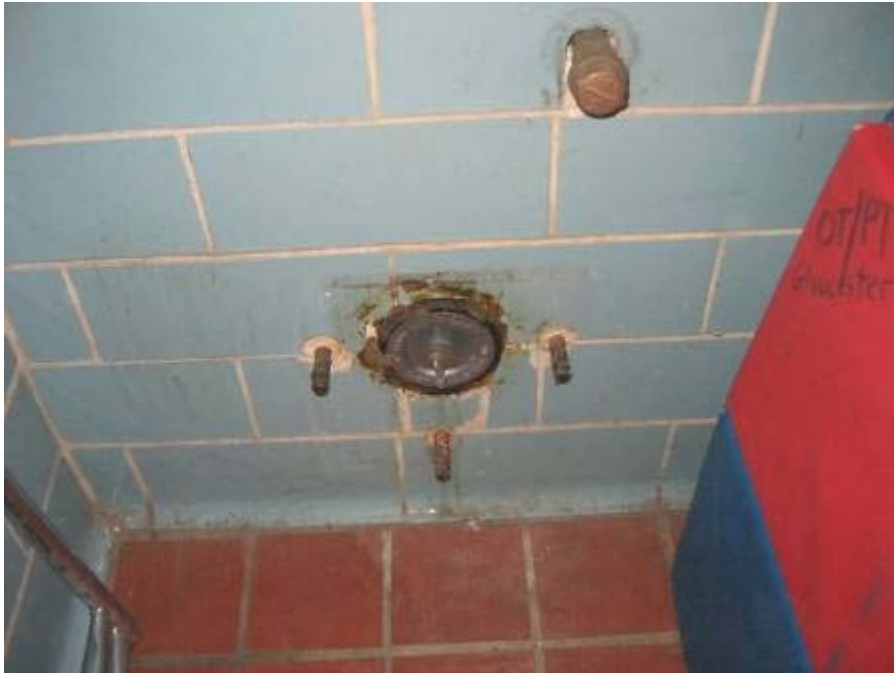
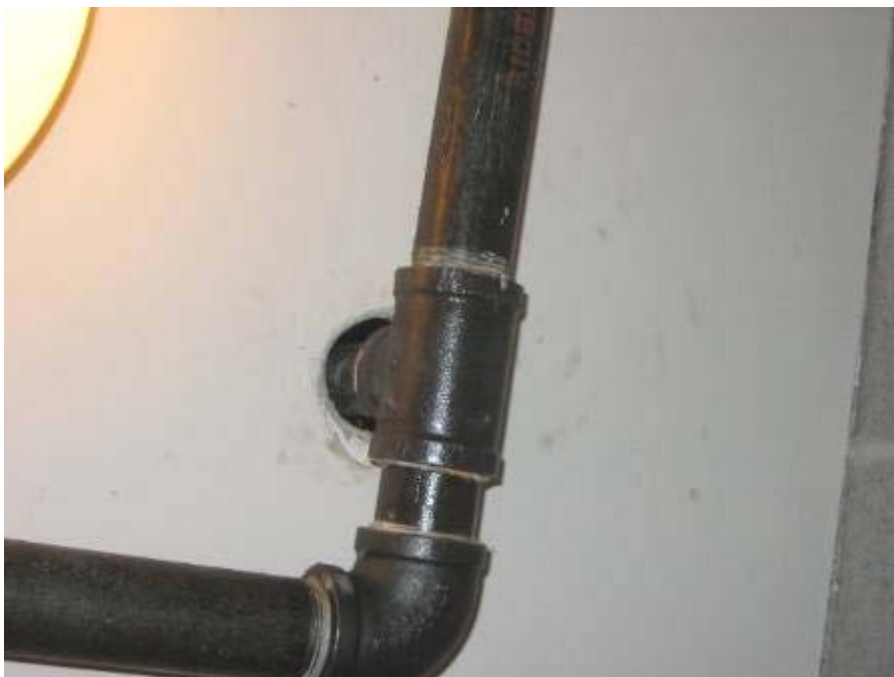
In addition, breaches around pipes and utility holes were observed in the gym office (Pictures 17 and 18). These spaces can allow materials and odors from behind the wall to penetrate and accumulate in the gym office. Consideration should be given to sealing holes and breaches to prevent accumulation of odors and related materials.

Spaces around shower accessories

Breach around pipe

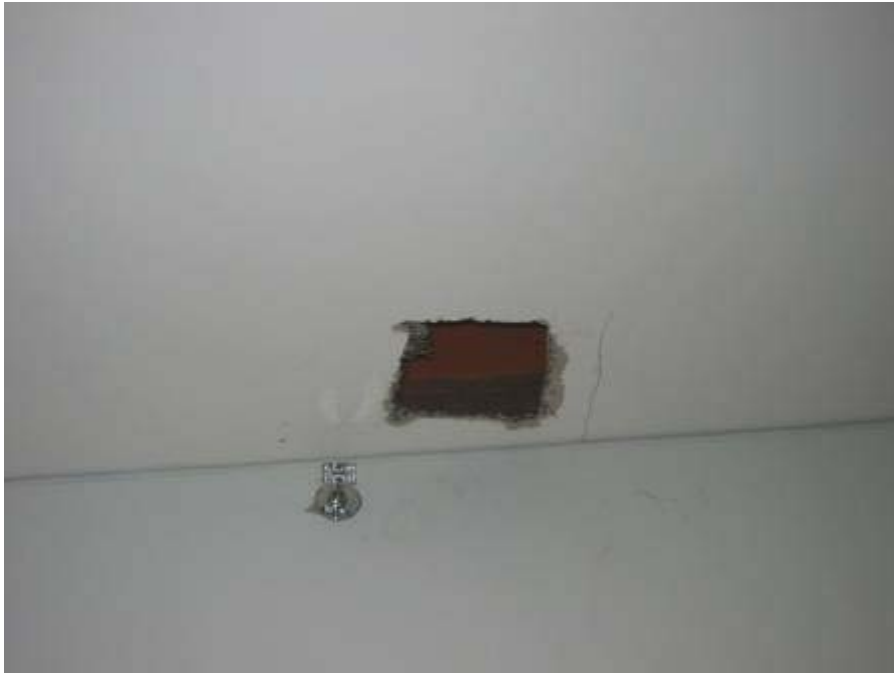
Picture 19

Cut out in ceiling of storage/copy room

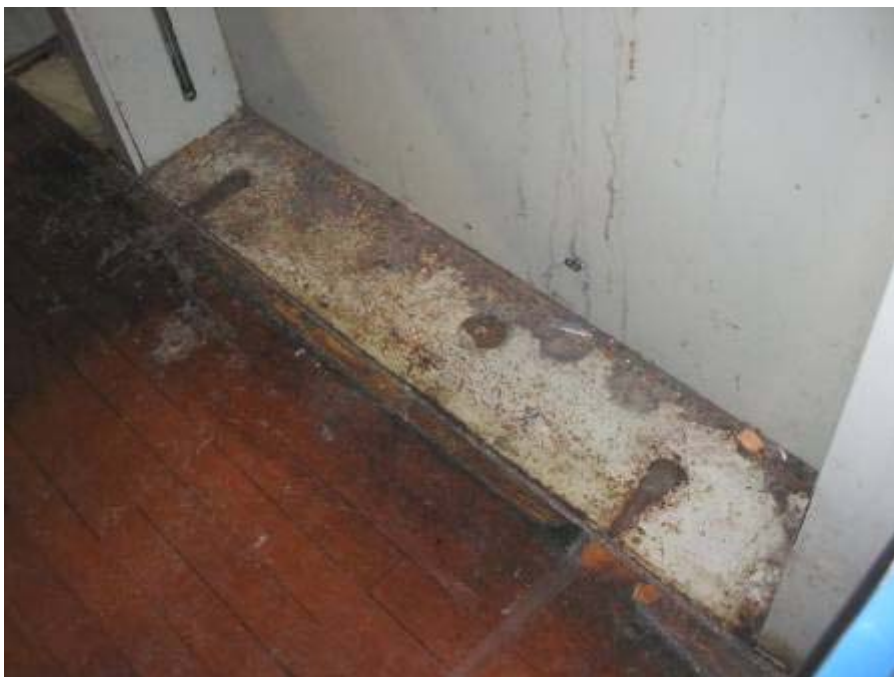
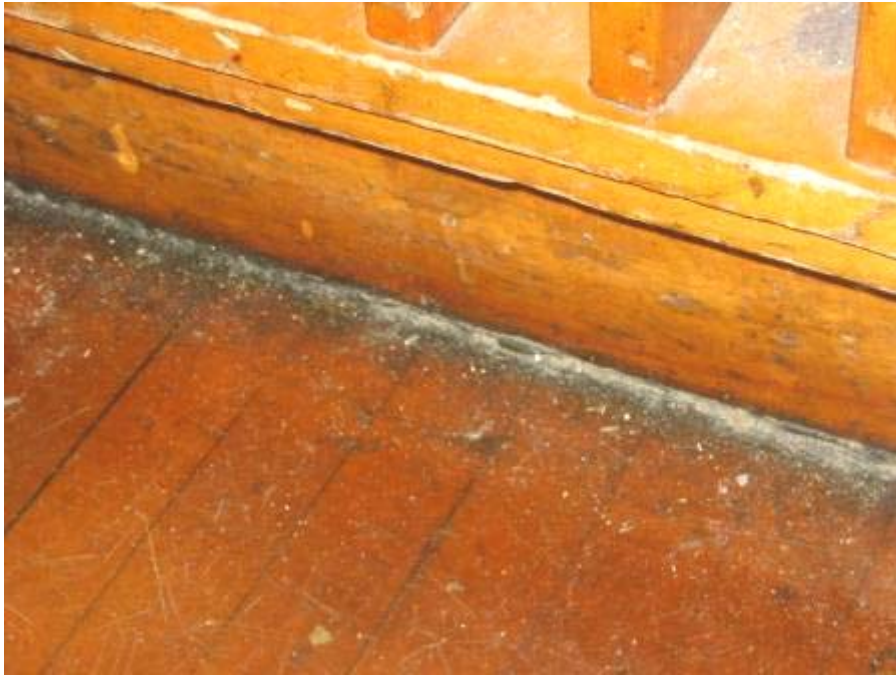
Dust accumulation was observed along the walls and floors of the gym (Pictures 20 to 21). The acoustical wall system in the gym makes cleaning difficult; however, removal of

Wall in gymnasium, note dust and debris accumulation

Dust accumulation on floor and between wood panels in wall

accumulated debris is recommended to prevent odor production (i.e. from old food particles). Consideration should be given to periodically vacuuming these areas with a high efficiency particle arrestance (HEPA) filtered vacuum cleaner.

18. Consider vacuuming gym with a HEPA-filtered vacuum to remove dust and debris.

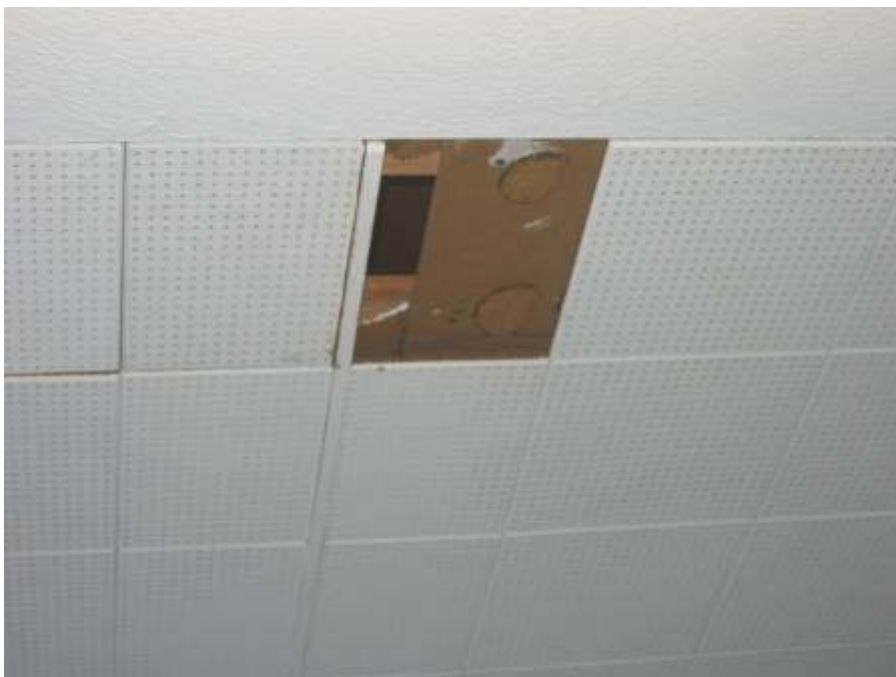
Picture 22

Missing ceiling tiles were observed in some areas (Picture 22). Items were also observed suspended from the ceiling tile system. Missing/ajar ceiling tiles can provide a pathway for materials (e.g., odors, dust, particulates) to migrate into occupied areas. Ceiling tiles should be flush with ceiling system to prevent such movement. Similarly, occupants should refrain from hanging items from the ceiling tile systems to prevent potential pathways for materials into occupied areas.

Missing ceiling tile

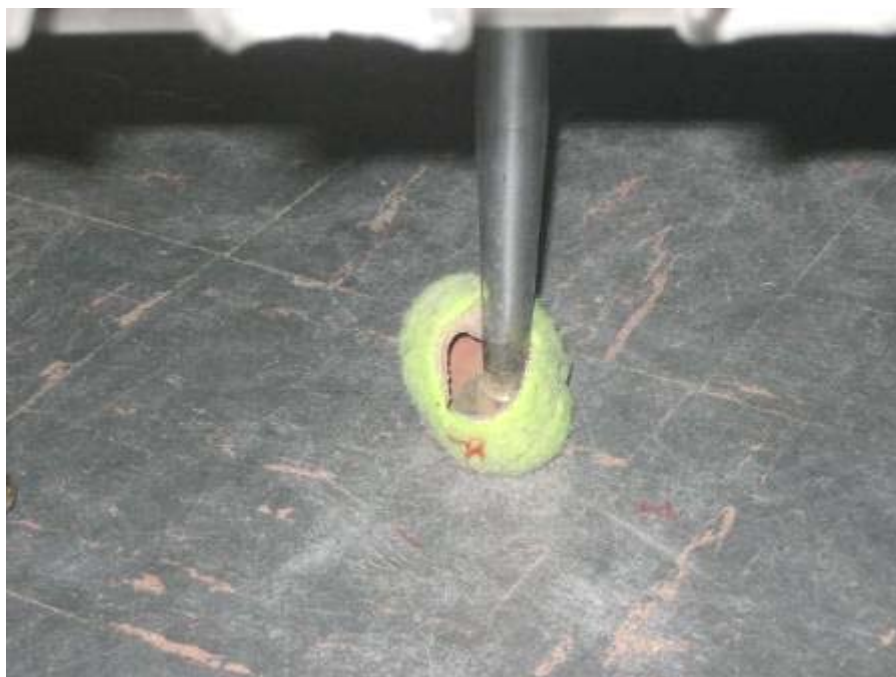
Picture 23

Lastly, in an effort to reduce noise from sliding chairs, tennis balls had been spliced open and placed on chair legs (Picture 23). Tennis balls are made of a number of materials that are a source of respiratory irritants. Constant wearing of tennis balls can produce fibers and off gas VOCs. Tennis balls are made with a natural rubber latex bladder, which becomes abraded when used as a chair leg pad. Use of tennis balls in this manner may introduce latex dust into the school environment. Some individuals are highly allergic to latex (e.g., spina bifida patients) (SBAA, 2001). It is recommended that the use of materials containing latex be limited in buildings to reduce the likelihood of symptoms in sensitive individuals (NIOSH, 1997). A

Tennis ball on chair leg

Consideration should be given to using latex-free tennis balls or rubber booties.
